U.S. ARMY ENGINEER REACTORS GROUP

Report OGB 15

Final Report on Investigation of SM-1
Control Rod Seal Failure

JOB 63 - INSPECTION
OF SM-1 CONTROL ROD
SEAL COMPONENTS

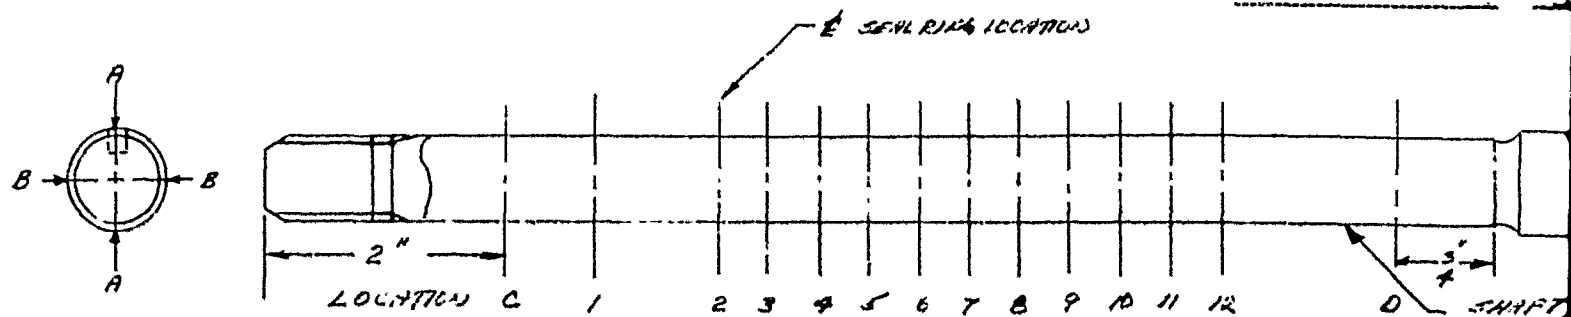
SKETCH #1

- * SHAFT #1 HAD NO IDENTIFYING MARKS, SHAFT #2 WAS MARKED "2".
- ① DUE TO THE ARRANGEMENT OF THE WEAR MARKS ON SHAFT #2 IT WAS CLEARLY EVIDENT THAT THE SEAL WAS INCORRECTLY ASSEMBLED. IT WAS ASSEMBLED AS FOLLOWS:

- ② ALTHOUGH THE MEASUREMENTS INDICATE LITTLE OR NO WEAR, EXAMINATION OF THE SHAFTS UNDER A MICROSCOPE SHOWED THAT THE CHROME PLATING HAD BECOME PITTED AT MOST OF THE SEAL RING MATING SURFACES. AT MANY PLACES THE DEGREE OF PITTING WAS SUCH THAT THE BASE METAL WAS VISIBLE.

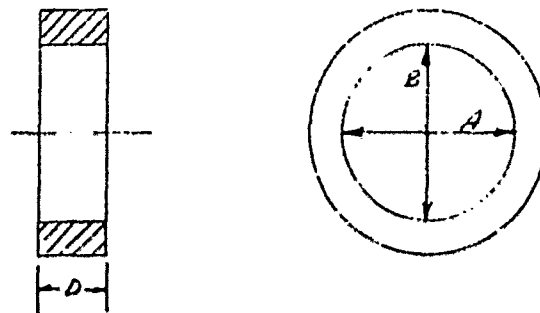
SKETCH # 2

① THERE WAS A CONSIDERABLE AMOUNT OF WEAR ON THE SIDE OF THE RINGS THAT MATES WITH THE SURFACE MARKED X IN THE ABOVE DIAPHRAM SKETCH. THE WEAR ON THE RINGS CONFORMED TO THE SHAPE OF SURFACE X. DUE TO THE ROUNDED ENDS ON THE MICROMETER ANVIL THE DEPTH OF THE WEAR WAS UNABLE TO BE DETERMINED. HOWEVER IT IS ESTIMATED THAT THE DEPTH WAS ONE TO TWO THOUSANDS OF AN INCH.

② ALL PARTS WERE ULTRASONICALLY CLEANED PRIOR TO ANY MEASUREMENTS AND NO SIGNIFICANT TRACE OF CRACK WAS EVIDENT

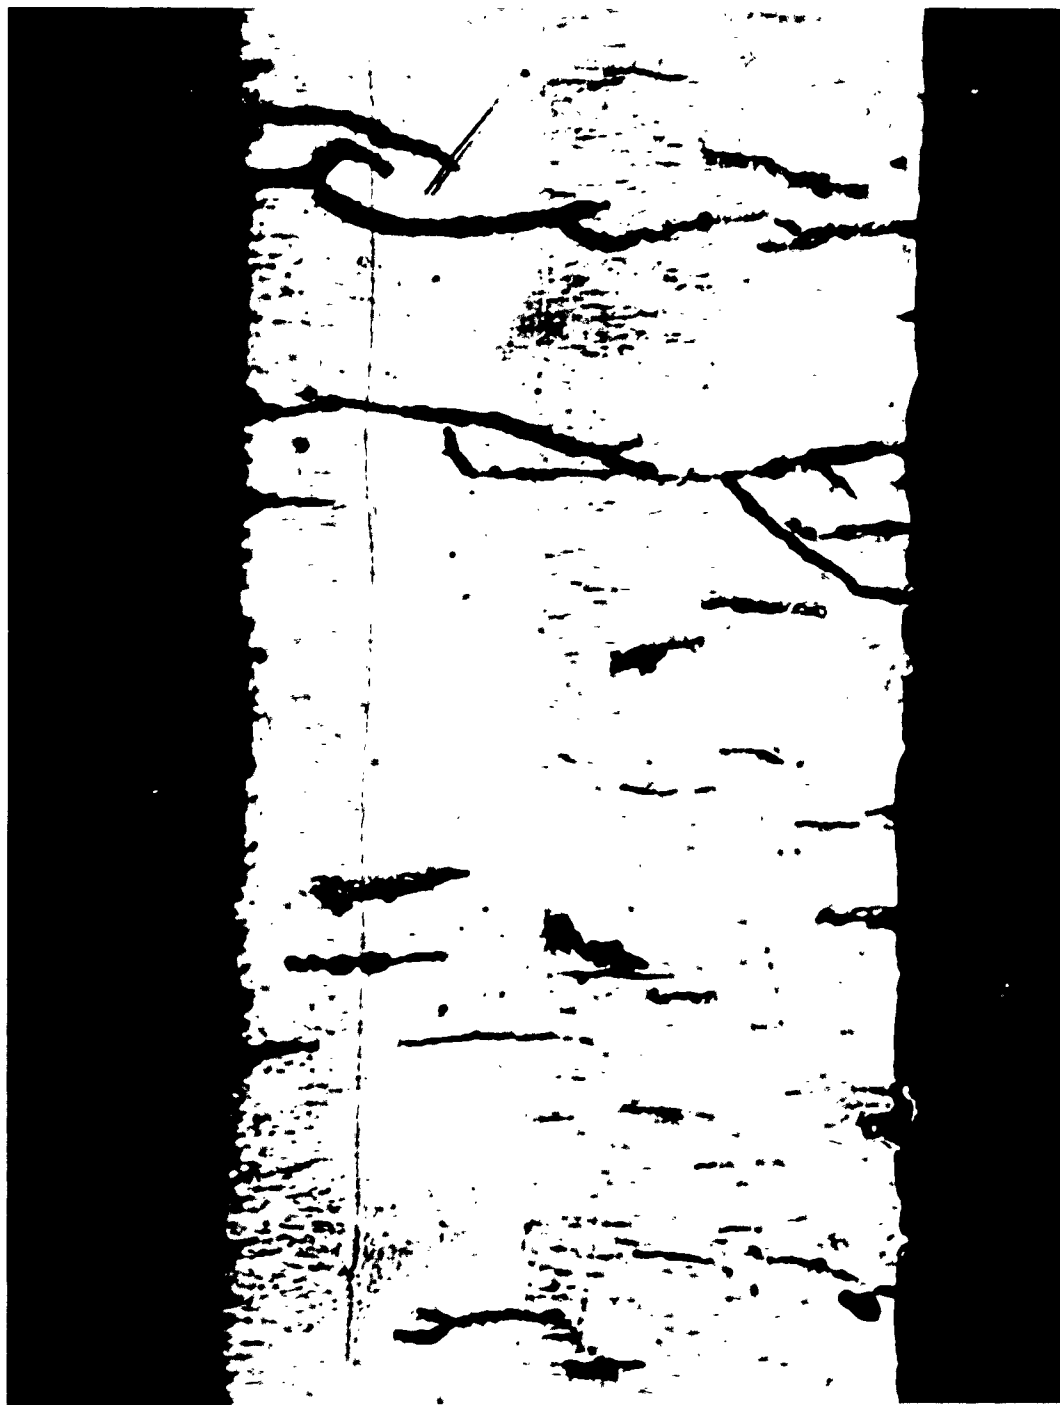
The deposit itself is definitely sedimentary. Three distinctly different layers are identified under polarized light, and may be seen on the bright field, Figure 5 at 950 diameters magnification, showing a relatively un-worn area.

Figure 5 - A Longitudinal Section Through a Relatively Unworn
Area of Chromium Plate. (950X)
